Island View Road

Evaluation of Conditions for Cyclists & Pedestrians

Prepared by Kevin McLoughlin
Trails Director – Parks & Trails New York

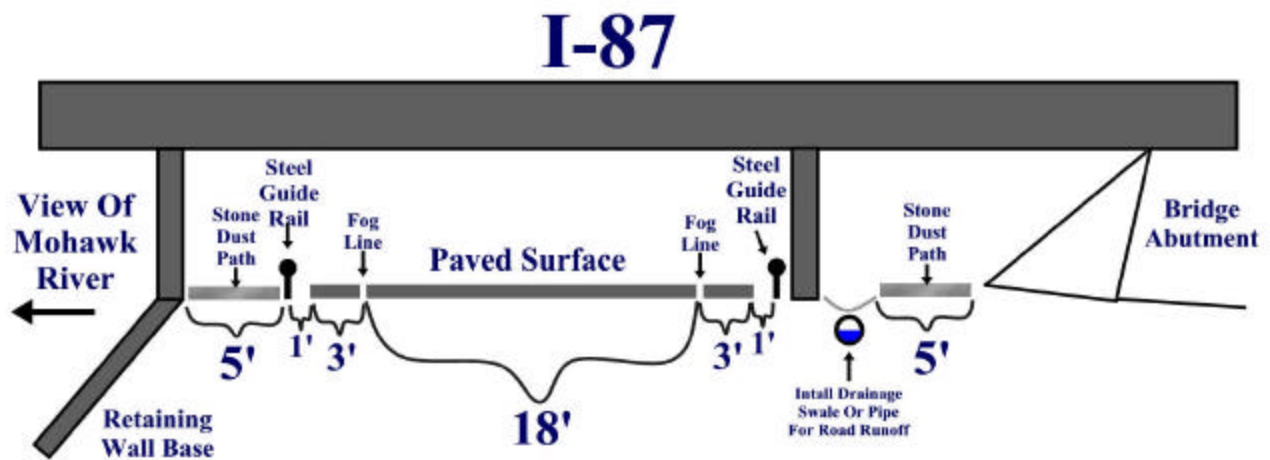
Figure 4

While there was adequate space for cyclists to share the paved road surface through the underpass at location A, the group felt that pedestrians would likely experience a ‘hemmed in’ feeling due to the concrete bridge piers located at the edges of the road. The northern pavement edge is approximately 7 feet from the concrete retaining wall while the southern pavement edge is approximately 3 feet from the concrete bridge piers. The narrowest width between bridge piers is 31.5 feet.

A guide rail is located on the north side of the underpass apparently to both prevent vehicles from flipping over a concrete retaining wall and to protect the supports for the twin bridges. The group agreed that neither CDTC nor NYS DOT would support a wholesale removal of this safety feature in any redesign. There is a small gap ranging from 1.3 feet to 2 feet between this guide rail and the concrete retaining wall through the underpass. There was an open corridor of 11 feet in width along the south side of the underpass between the bridge piers and the I-87 bridge abutment which serves as a drainage area for the underpass roadway and feeds into a large (approximately 3x3 feet) drainage grate at the I-87 centerline.

- 11) Consider moving guide rail on north side of roadway in underpass (on left of Image 3) a uniform 5 feet from the concrete retaining wall and surface with crushed stone as pedestrian walkway and plan a 2 foot minimum pedestrian access opening 'gap' in same guide rail approximately 10 to 20 feet beyond both east and west edges of I-87 bridge...there is sufficient room for this treatment plus guide rail on either side of 3-foot shoulders and 9-foot travel lanes overlapping the paved edge of roadway (see Figure 4)

- 12) Consider using open drainage area on south side of underpass between bridge piers and abutment (on right of Image 3) as pedestrian access corridor with surface of crushed stone, using design and possibly subsurface drainage structures to maintain area and grate drainage function (see Figure 4)...It not likely necessary to add a guide rail on the opposite side of the roadway since under the NYS Highway Design Manual the underpass is equivalent to a tunnel/bridge grade-separation structure and the NYS Bridge Manual standards indicate that on this type of road with low ADT, the paved shoulder width constitutes sufficient horizontal clearance from fixed objects

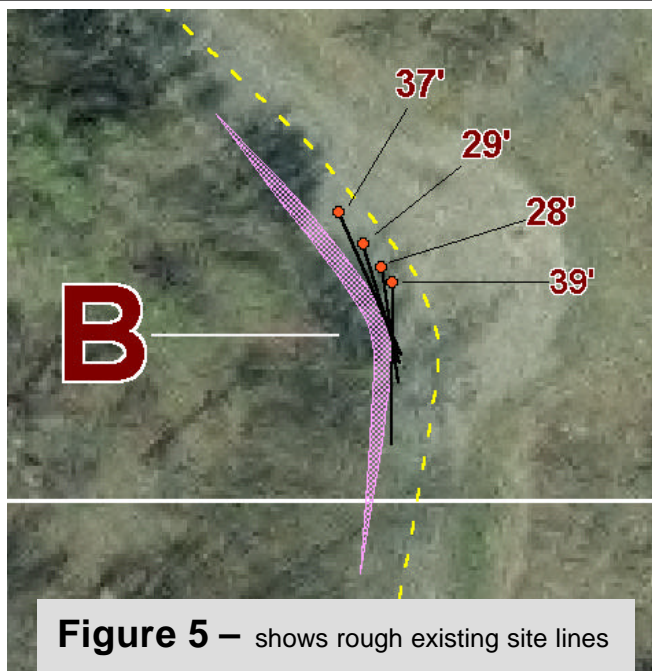
Sight distance along the westbound lane is restricted by a soil and vegetation-covered slope, which overlies a limestone and shale rock outcrop adjacent to the roadway edge at location B in Figure 1 and seen on the right in Image 1 and on the left in Image 2. This condition may not allow a motorist sufficient time to avoid a cyclist or pedestrian moving along the narrow shoulder area.

Figure 5 – shows rough existing site lines

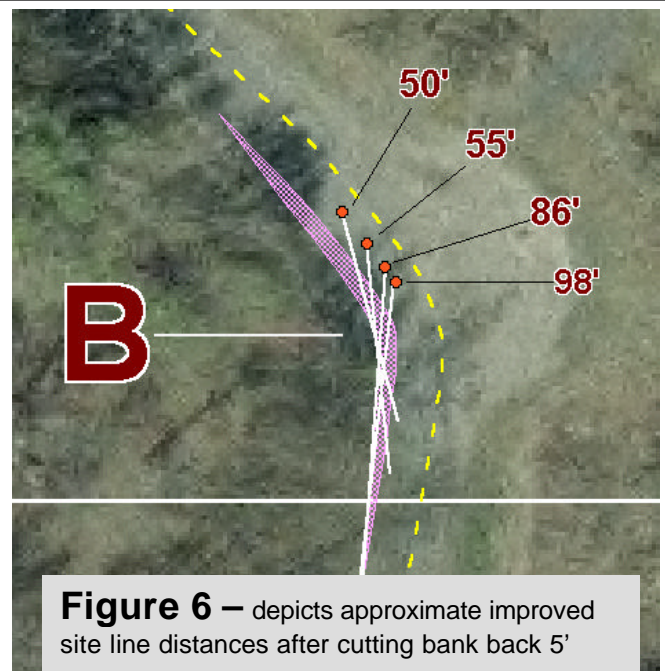
Figure 6 – depicts approximate improved site line distances after cutting bank back 5'

- 8) Consider treating newly defined shoulders with a colored and texturized surface such as that along Route 787 in Cohoes if local budget and aesthetic considerations support it
- 9) Consider cutting into outcrop (on north side of road at location B in Figure 1 and on left in Image 1 and on right in Image 2) as practical with backhoe jackhammer tool to obtain a cut of approximately 3 to 5 foot depth from base of outcrop at the inside apex of the

curve and tapering out to either side for approximately 40 to 60 feet as depicted by shaded area in Figure 2
