Island View Road

Evaluation of Conditions for Cyclists & Pedestrians

Prepared by Kevin McLoughlin
Trails Director – Parks & Trails New York

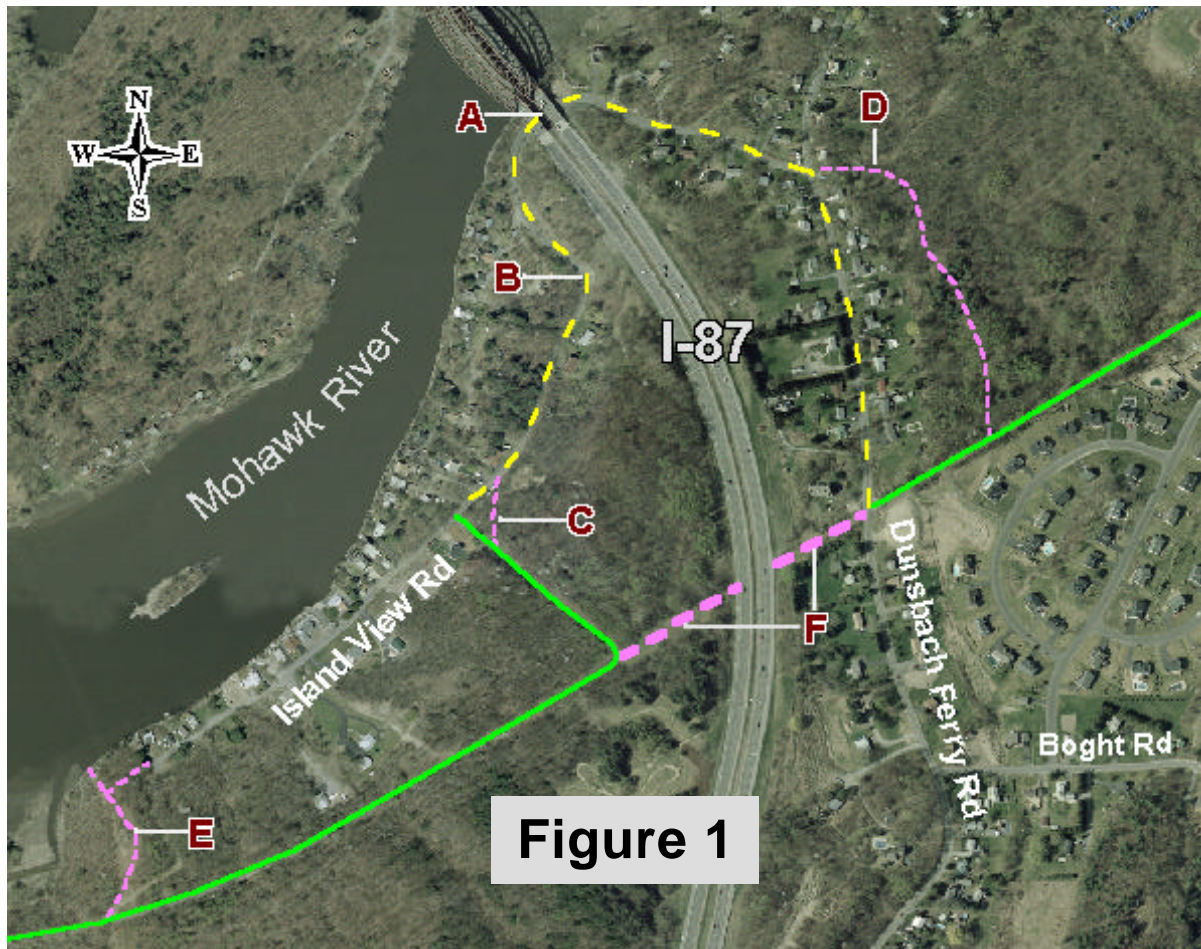
Sight distance along the westbound lane is restricted by a soil and vegetation-covered slope, which overlies a limestone and shale rock outcrop adjacent to the roadway edge at location B in Figure 1 and seen on the right in Image 1 and on the left in Image 2. This condition may not allow a motorist sufficient time to avoid a cyclist or pedestrian moving along the narrow shoulder area.

- 3) Extend compacted sub base a further 2 feet between the paved roadway edge and any drainage swales (as practical using existing right of way)
- 4) Remove brush and cut away loose soil and rock from rock outcrop along westbound travel lane at location B in Figure 1 and left side of Image 1 and right side of Image 2 to improve visibility for all users

- 8) Consider treating newly defined shoulders with a colored and texturized surface such as that along Route 787 in Cohoes if local budget and aesthetic considerations support it
- 9) Consider cutting into outcrop (on north side of road at location B in Figure 1 and on left in Image 1 and on right in Image 2) as practical with backhoe jackhammer tool to obtain a cut of approximately 3 to 5 foot depth from base of outcrop at the inside apex of the

- 1) Obtain easement on property adjacent to eastern edge of off-road pathway ramp descending to Island View Road indicated by the dotted line at location C in Figure 1 (location of re-route is approximate) in order to bypass unneeded elevation loss by contouring around slope to intersect roadway at a point further to the east where it is level with a point roughly 1/3 of the way up the existing slope (easement location would need to work around wetlands observed by group as close to road at this location)

- 2) Obtain easement for trail as part of proposed new development indicated by dotted line at location D in Figure 1 (location of easement is approximate) in order to bypass least desirable on-road trail segment along Dunsbach Ferry Road and connect new development to trail corridor

- 3) Obtain easement for trail to allow pedestrian access from trail and Island View Neighborhood to viewpoint of Mohawk River at utility line corridor as indicated by dotted line at location E in Figure 1

- 1) Use the currently unused but town-owned portion of railroad right-of-way indicated by dashed lines and labeled F in Figure 1 for compacted earth approach ramps
